From: Pardee, Michael <mpardee@Sciame.com>
Sent: Friday, May 03, 2019 12:35 PM
To: James Dearth; Murphy, Ryan; Giusti, Adam; Asante, Joseph; Buhler, Jacklyn
Cc: Steven Grzic; Phil Carvelas; Porcelli, Michael
Subject: RE: CUNY - PCO#098 - WT-3 Clerestory Remediation
Attachments: CUNY_Design Movement Between Aud and Main Bld_Submittal
084426-07-01.pdf

ASK-266:
WT-3 HEAD ANCHOR
DETAIL: RFI 1130
04/27/17

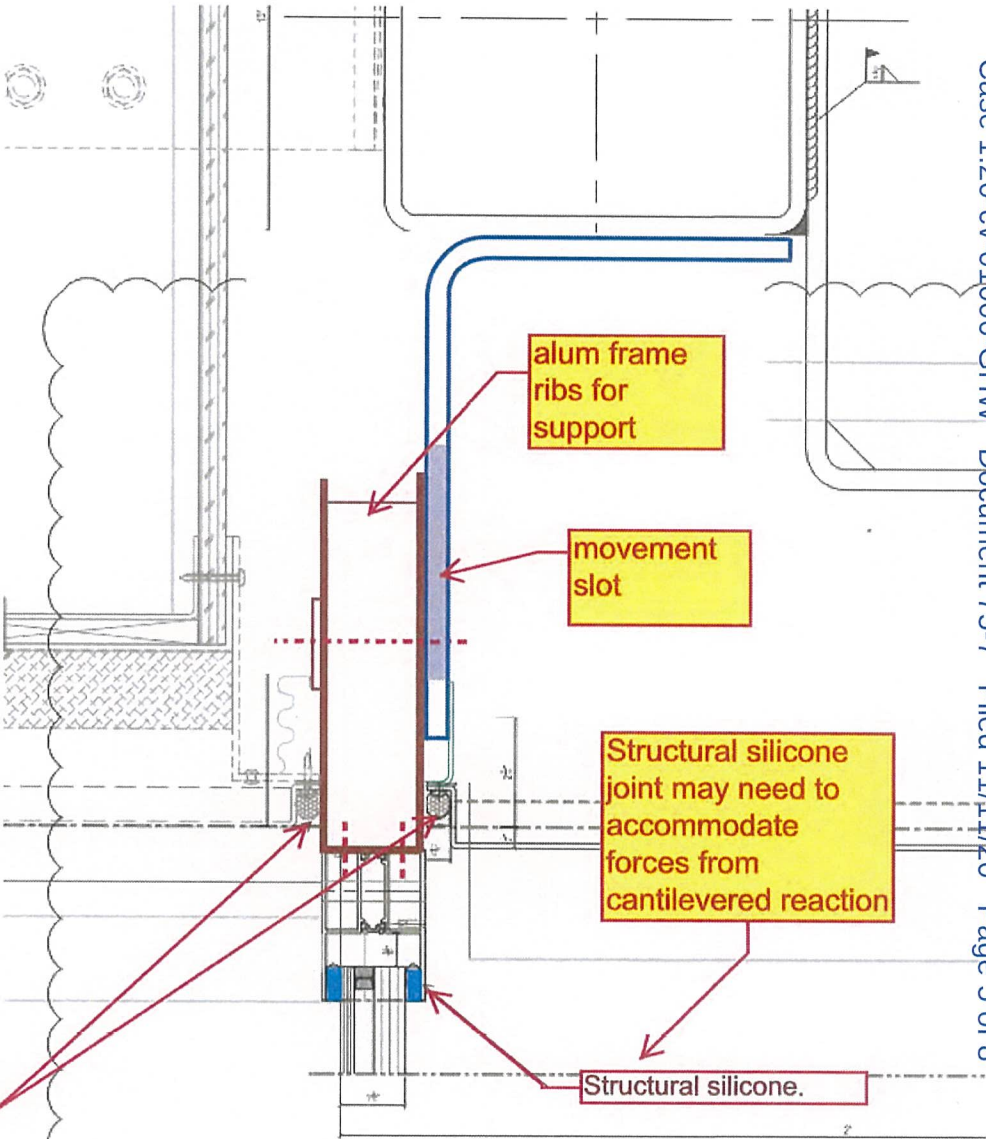
HEAD ANCHOR DOWN POSITION:

1. SHOP DWG SUBMISSION NUMBERS MUST BE IN SEQUENCE OF THE PREVIOUS SUBMISSIONS
2. THE CONCERN WAS PREVIOUSLY NOTED IN 2014 UNDER SUBMITTALS 084413-020-01 AND 084413-020-02 ON SHEETS D328, D329, D331 AND Y52 TO VERIFY A LARGER MOVEMENT JOINT TO ACCOMMODATE ROOF DEFLECTIONS. THE NOTE WAS ALSO INDICATED ON RFIS 1033 AND 1033R1.
3. REFER TO ATTACHED ESTIMATED ROOF DEFLECTIONS BY WSP. NOTE: WSP CLARIFIED 50% OF THE SDL HAS ALREADY OCCURRED AND THAT FIGURE CAN BE REDUCED. EVEN WITH THE 50% REDUCTION OF THE SDL DEFLECTION, WE BELIEVE THE CONTRACTOR'S HEAD ANCHOR DETAIL MAY NOT ACCOMMODATE THE ESTIMATED ROOF DEFLECTIONS
4. REFER TO ASK- 266 FOR SUGGESTION FOR THE HEAD ANCHOR DETAIL TO ACCOMMODATE POTENTIAL MOVEMENT

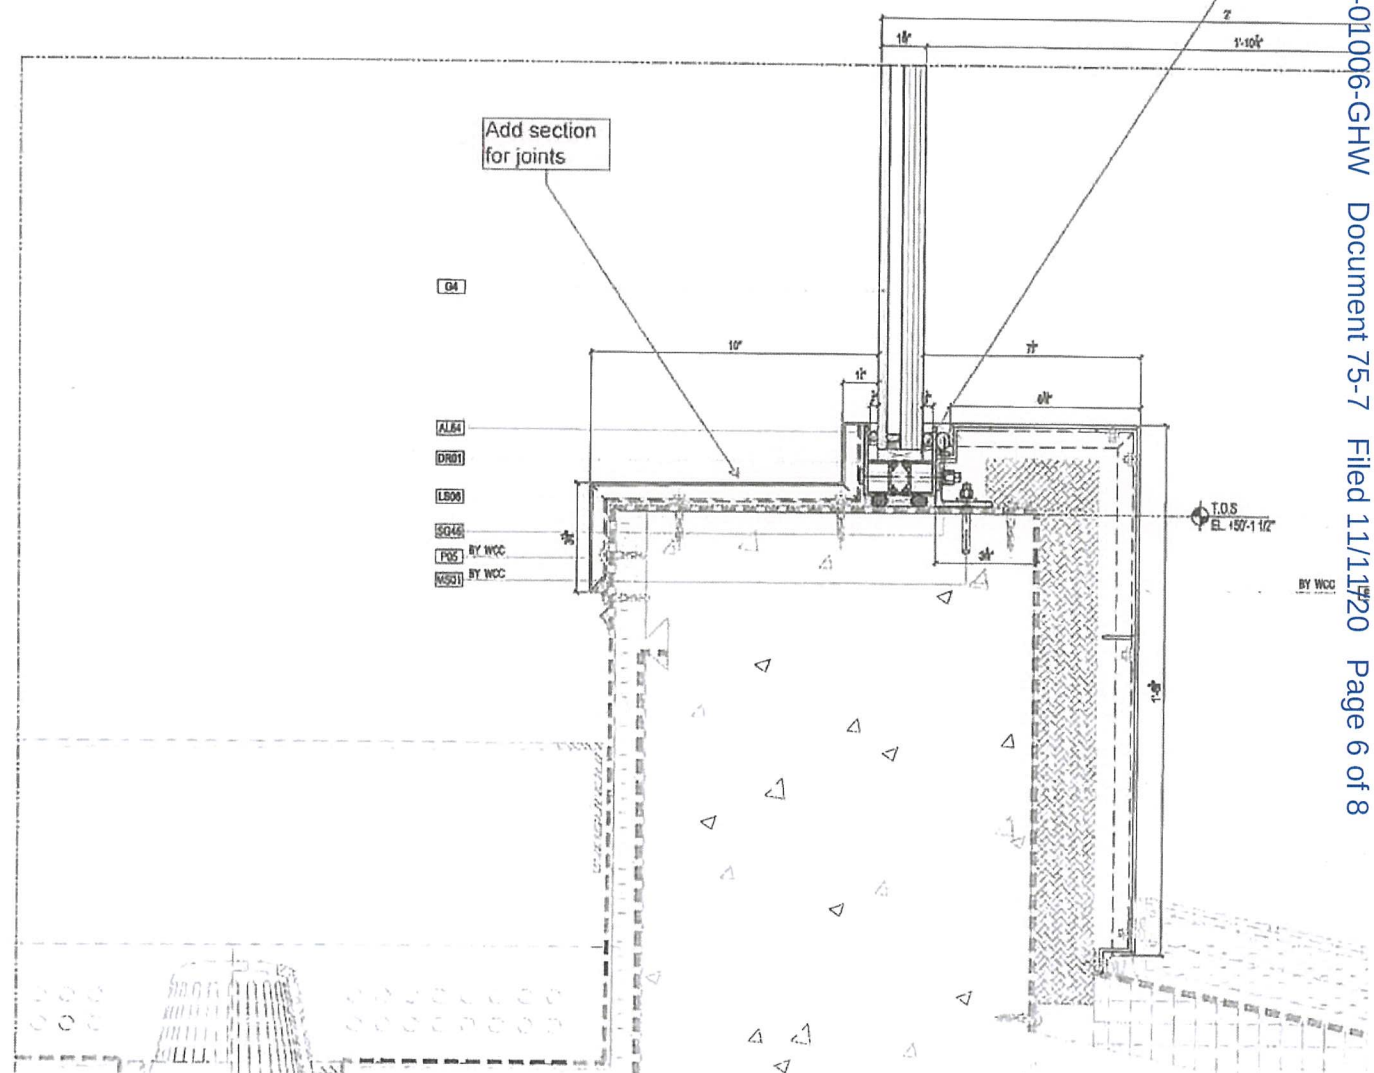
The glass must transition from sitting at some location. Where this happens on elevation add required details. Note, we want this to happen at a column line. There will be little vertical movement.
